DiamondWrap® HP™ 10” Wrinkle Bend Repair in Canada

Customer: Liquids Pipeline Operator

Pipe Diameter: 10”

Pipe Defect: Wrinkle Bend

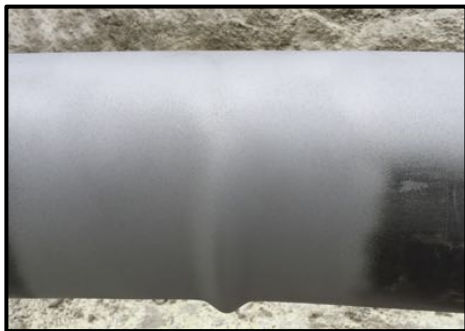
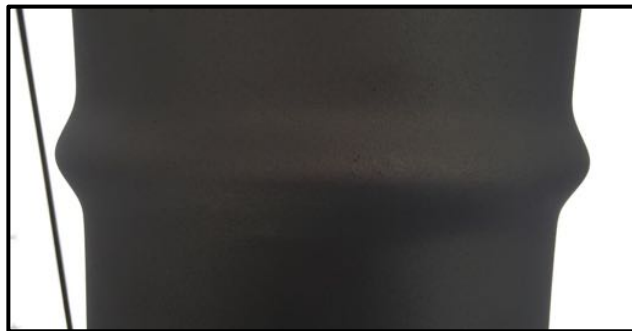
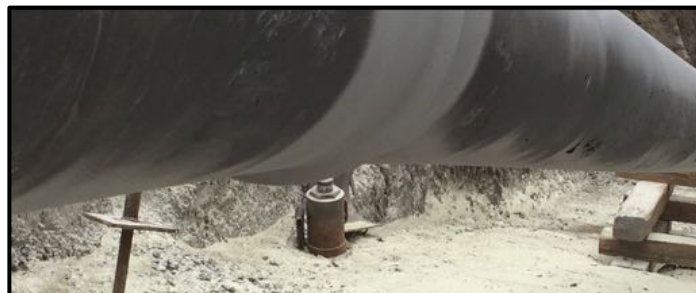
Inspectors for a liquids pipeline operator in Canada found a wrinkle bend on a 10” crude oil transport pipeline. The operator could not afford to shut down the line to cut and replace because of the high transport volume through the pipe. A welded sleeve could not be used because of the odd configuration of the anomaly. Pictures of the anomaly are below.

Citadel Technologies’ team of project engineers designed a repair for the wrinkle bend defect according to ASME PCC-2 Article 4.1, and recommended a DiamondWrap® HP™ repair solution. 6 layers of DiamondWrap® HP™ were required to repair the defect.

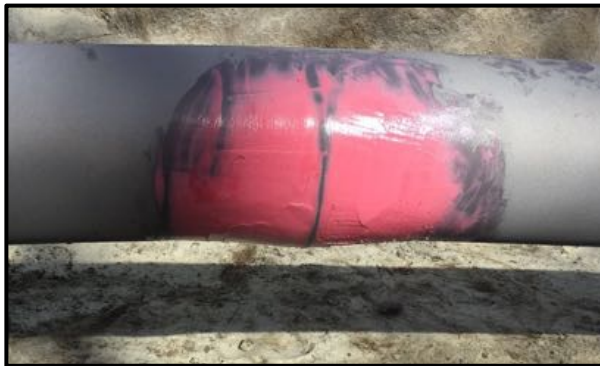
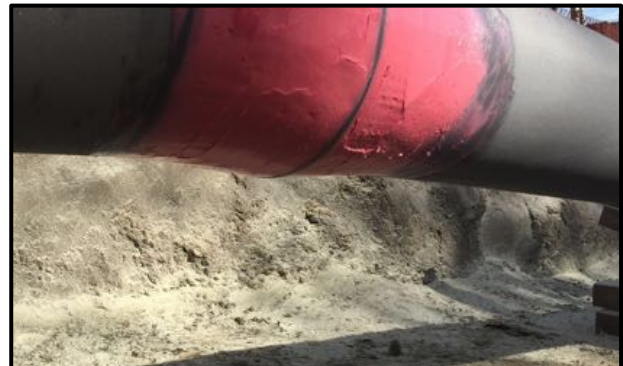
High compressive modulus load transfer epoxy used to smooth anomaly

Citadel had previously teamed with the specified contractor on previous Canadian DiamondWrap® HP™ repair opportunities, and the contractor already had several trained and certified installers. This partnership with the contractor saved the pipeline operator time and money as they did not have to call out two separate service companies to perform both the dig and the installation. The repair also did not require the high cost of welding labor. The high compressive modulus filler putty was installed to smooth any stress concentrations around the wrinkle bend as a material to transfer the load from the pipe to the carbon fiber repair system. The primer was installed next to increase the bond between the repair and the pipe. 6 layers of carbon fiber were installed over a 1 meter repair length to repair the wrinkle bend defect.

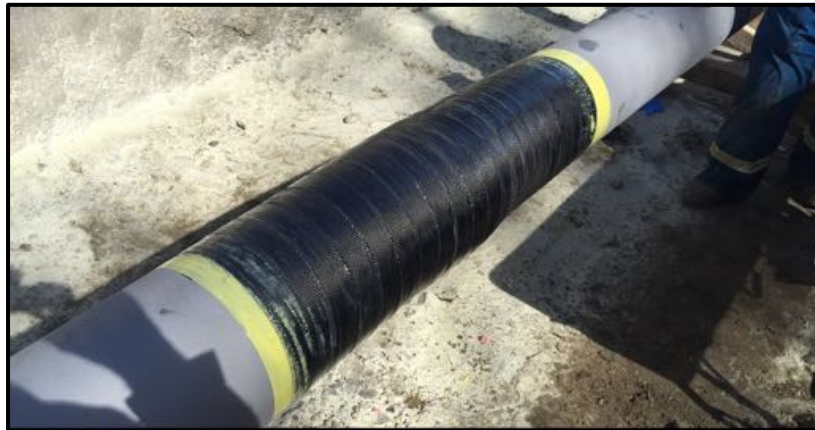
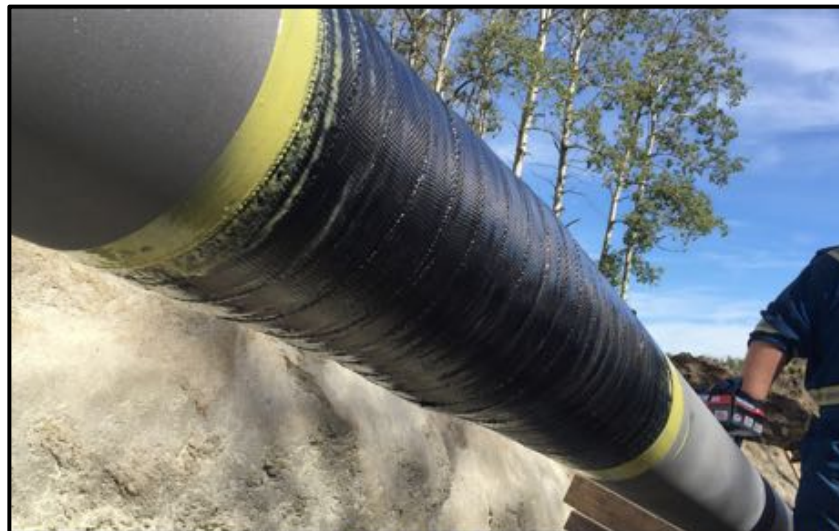
Completed DiamondWrap® HP™ repair

Two trained technicians were able to complete the installation within approximately 2 hours. No heavy equipment or hot work was required for the installation, and the line remained in operation during application. The repair was installed and cured within a half of a day, allowing the pipeline operator to quickly and efficiently move on to future digs. Below are photos of the completed repair and repair process.
