DiamondWrap® HP™ 12” Damaged Elbow Repair in Canada

Customer: Natural Gas Storage, Transmission, and Distribution Company

Pipe Diameter: 12”

Pipe Defect: External Corrosion, Gouges, and Arc Burns on a Gas Transmission Elbow

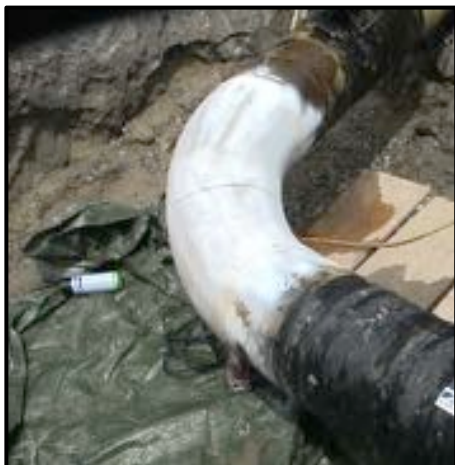
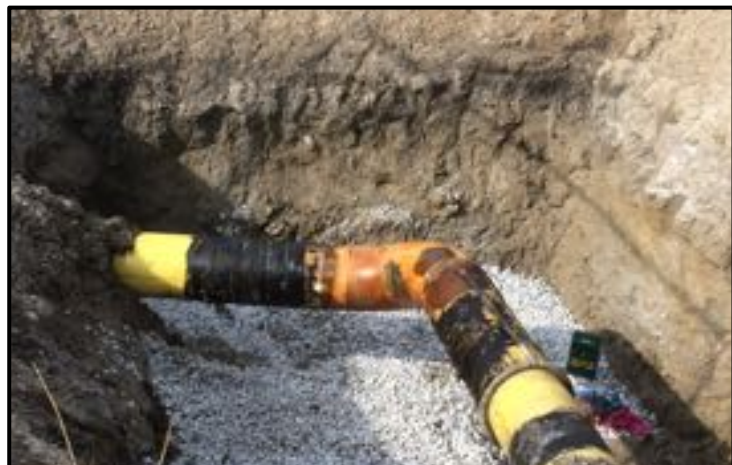
This gas cogen line was suffering from external corrosion, gouges, and arc burns. Many miles of pipeline would have to be blocked in and purged in order to cut the line and weld in a fresh section of pipe, costing the company hundreds of thousands of dollars. Additionally, the configuration that required repair consisted of two 45 degree elbows that changed the depth and direction of the pipeline. This configuration is not repairable with welded sleeves, and other traditional repair methods such as a clamp would not be as easily installed. A rigid composite repair system would also not be feasible. The result would be a costly repair with heavy equipment and lots of hot work, lost production time, and lost gas. Following are pictures of the damaged pipe.

Citadel Technologies’ team of engineers designed repairs for each defect according to ASME PCC-2 Article 4.1, and recommended a DiamondWrap® HP™ repair solution. Only 4 layers of DiamondWrap® HP™ were required to repair the defect, even with the high design pressure.

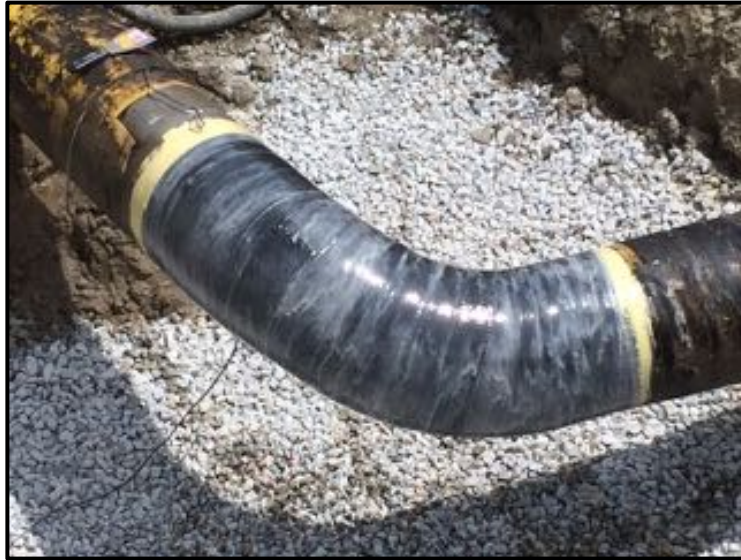
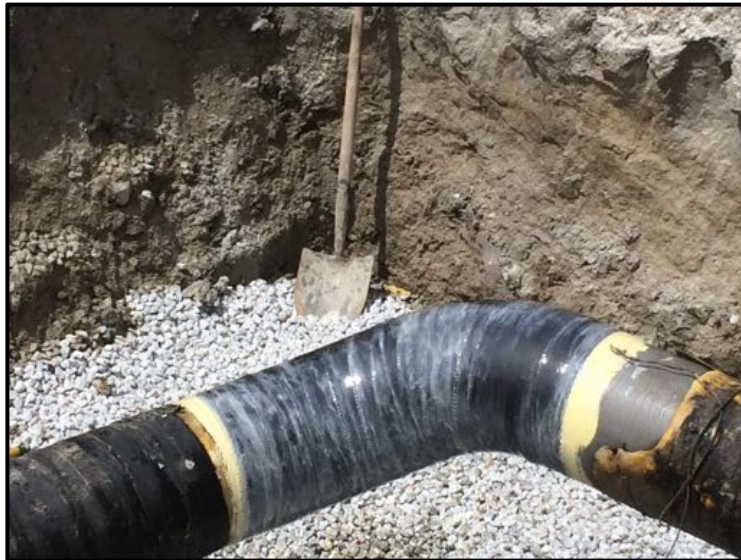
Completed DiamondWrap® HP™ repair
