DiamondWrap® HP™ 16” Dented/Gouged Natural Gas Pipeline

Customer: Natural Gas Utility Company

Location: Canada

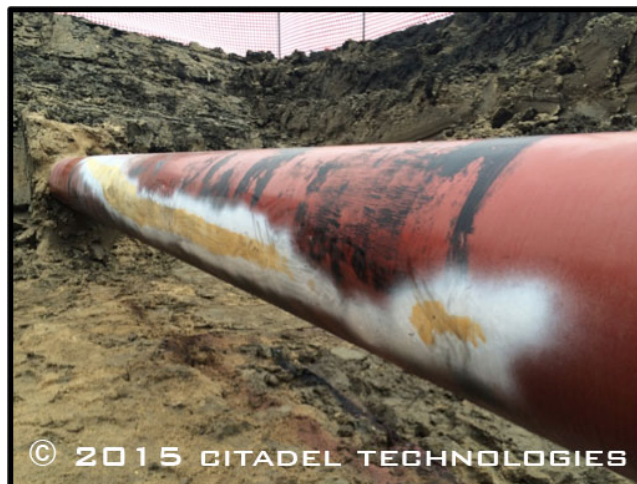
Pipe Defect: Dent and gouge extending approx. 130” axially along the pipe

Manitoba Hydro approached Citadel Technologies with a gas pipeline that had been damaged by road construction nearby. The loss of integrity required a repair solution to ensure a safe environment for the nearby population, and operational restrictions were not conducive for a shutdown.

Citadel Technologies' team of highly skilled engineers designed a repair according to ASME PCC-2 Article 4.1, and recommended a DiamondWrap® HP™ repair solution to the customer. Only 4 layers of DiamondWrap® HP™ were required to repair the defect.

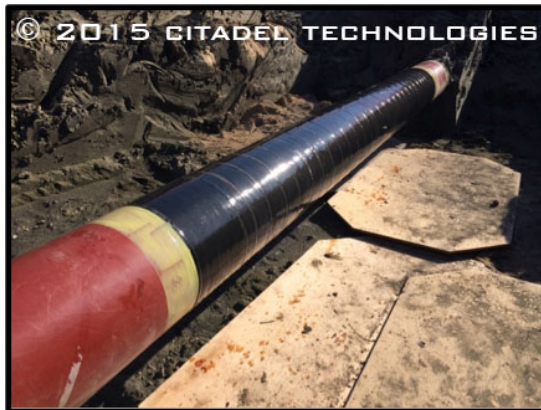
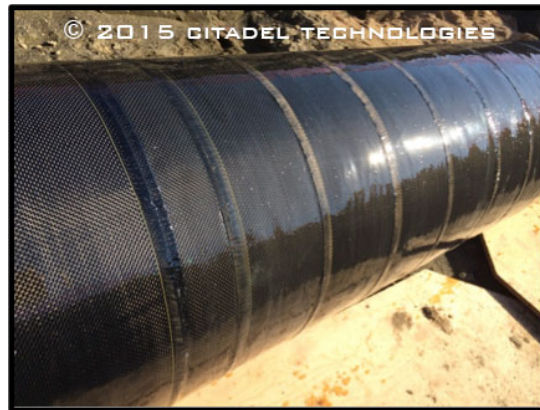
A team of trained and certified installers installed 4 layers of carbon fiber over the specified repair area, according to the calculations prepared by the Citadel Technologies engineer. The repair cured overnight, and the ends were wrapped with a tape to prevent CP leakage. Below are photos of the completed repair:
