DiamondWrap® HTA™ 1”–16” Odd Geometry Piping Repair in USA

Customer: Large Refinery

Pipe Diameter: 1”-16”

Design Pressure: 700 psi

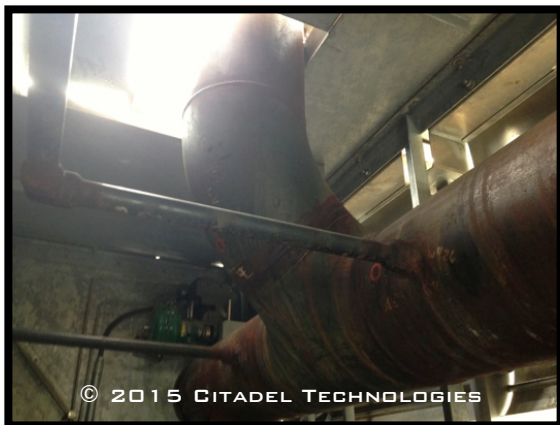
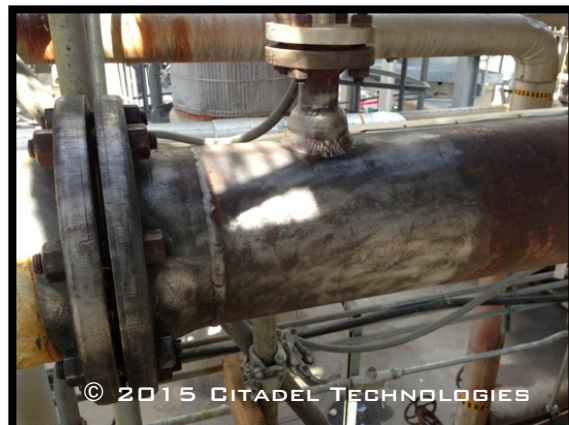
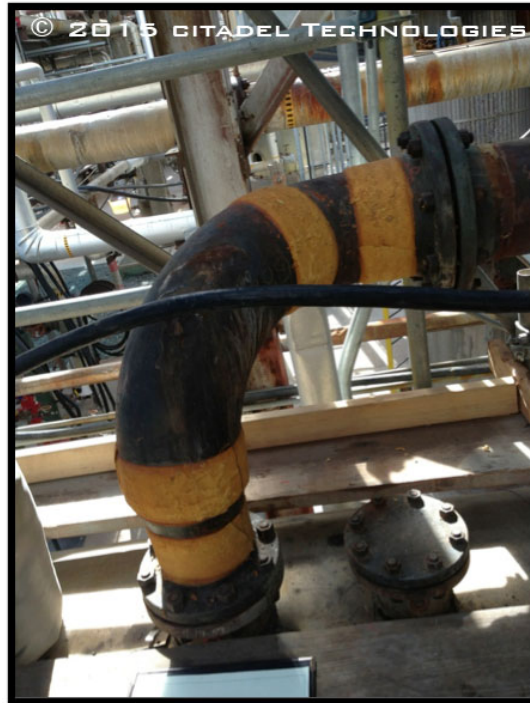
Pipe Defect: Internal corrosion at all welds in this section of piping.

Poor heat-treating practice led to failing welds in the Heat-Affected Zone (HAZ). These failing welds were then wrapped with a competitor’s discount fiberglass repair product. This repair proved to be inadequate, and also started leaking. Citadel Technologies was called in by a distributor to engineer a safe and effective design that would keep the customer on-line until their next turnaround.

Citadel Technologies' team of engineers designed repairs for each defect according to ASME PCC-2 Article 4.1, and recommended a DiamondWrap® HTA™ repair solution to the refinery. Only 4 layers of DiamondWrap® were required to repair the defect at the given pressures. Repairs were designed for Tees, straight runs, elbows, reducers, and even flanges. Many of these geometries would be prohibitive of using clamps. Review the attached calculations and information on the engineering assessment as a reference for the competent design capabilities of Citadel Technologies.
