DiamondWrap® HTA™ 30” Flare Line Rehabilitation in Kuwait

Customer: Refining Company

Location: Kuwait

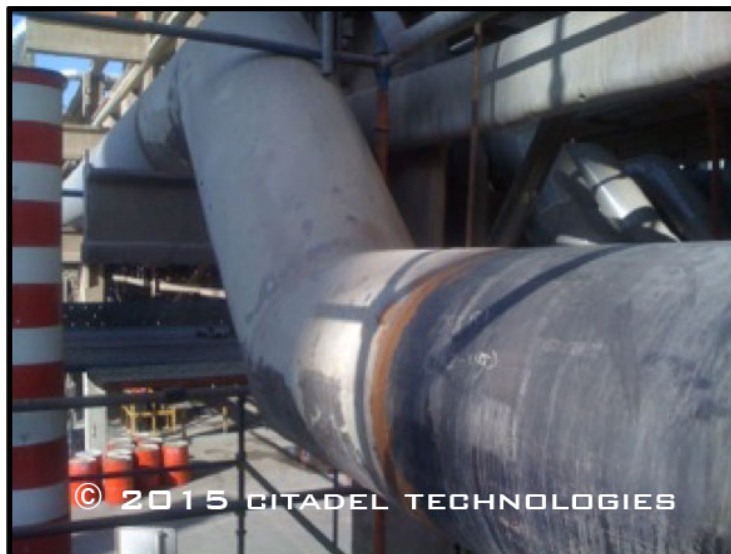
This flare line was suffering from internal pitting due to the harsh chemistries in the line. The pitting was primarily at the 6 o'clock, but extended midway up the walls. Pit depths were up to 3mm, and continuing uninhibited. The plant was at risk of shutdown if the corrosion continued and developed into a through-wall defect. The length of the corroded area extended over 50 meters, and encompassed straight runs, tees, and elbows.

Citadel Technologies’ team of engineers designed repairs for each defect according to ASME PCC-2 Article 4.1, and recommended a DiamondWrap® repair solution. Only 2 layers of DiamondWrap® HTA™ were required to repair the defect.
