# DiamondWrap® Acid™

## 36” Nitrogen Plant Flare Line Repair in USA

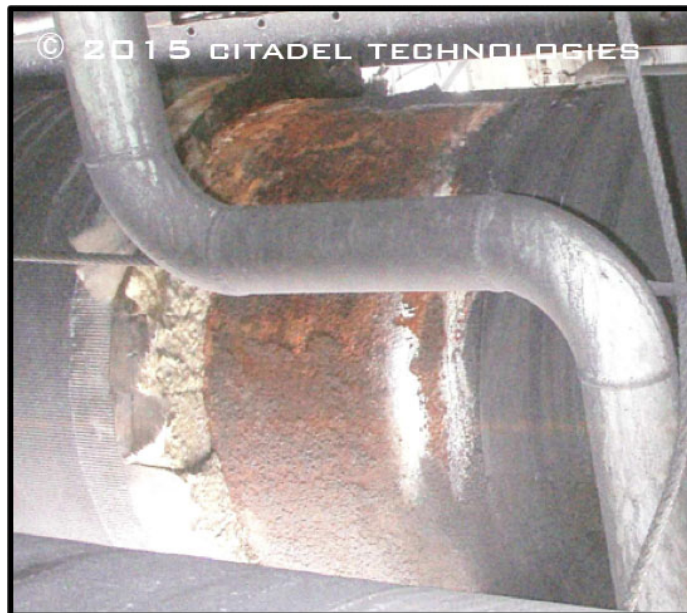
This flare line was suffering from severe external corrosion due to moisture seeping into the line’s insulation. The insulation broke down and created acidic conditions on the surface of the pipe. Along with the general internal corrosion from the line chemistry, this led to extreme scale and through-wall defects.

Citadel Technologies’ team of engineers designed repairs for each defect according to ASME PCC-2 Article 4.1, and recommended a DiamondWrap® repair solution. Only 2 layers of DiamondWrap® Acid™ were required to repair the defect.

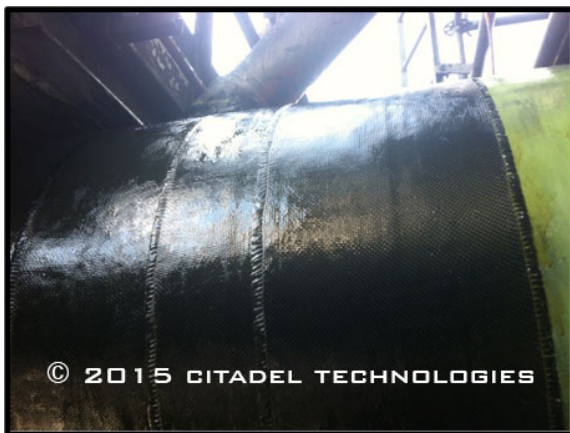
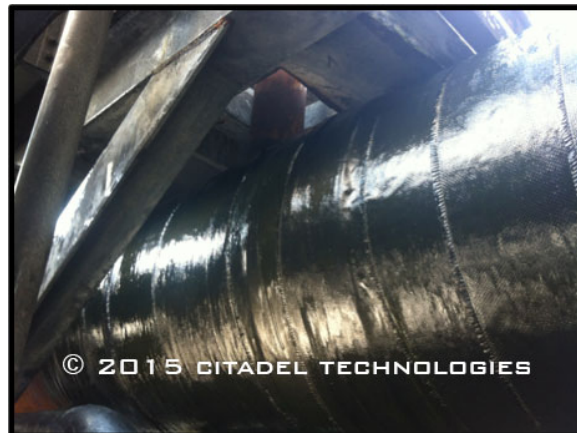
A small team of trained and certified installers installed layers of carbon fiber over the specified repair area, according to the calculations prepared by the Citadel Technologies engineer. No heavy equipment or hot work was required for the installation, and the line was in operation with no disruption in production. DiamondWrap® InstaSet™ patches were used to stop small leaks before installing the structural repair. The repair was completed in 3 sections as per the request of owners. The first section of repair involved wrapping 7 feet of the pipe, the second was to wrap 15 feet of pipe, and the final installation was to wrap the final 30 feet. Below are photos of the completed repair:
