# BlackDiamond® 8” Air/Ground Corrosion Repair in USA

**Customer:** Natural Gas Pipeline Company

**Pipe Diameter:** 8”

**Pipe Defect:** General External Corrosion and Pitting Around Air/Ground Transition

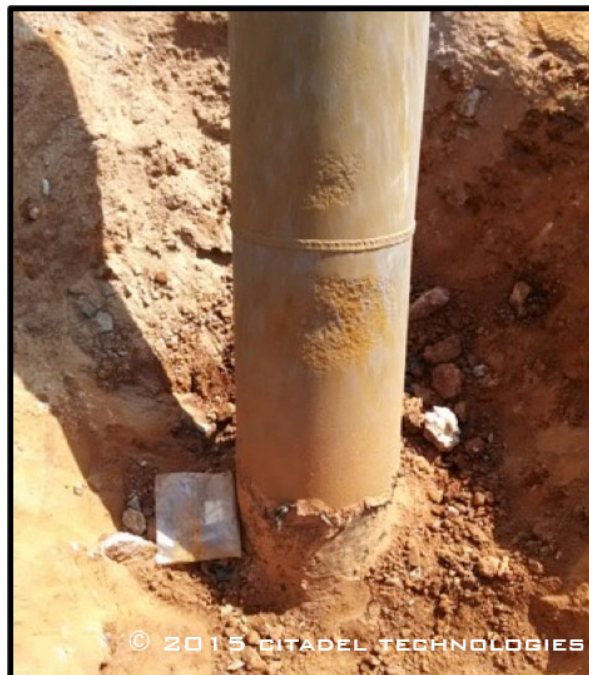
This gas gathering line was suffering from external corrosion and general pitting at the air to ground interface. Many miles of pipeline would have to be blocked in and purged in order to cut the line and weld in a fresh section of pipe. The result would be a costly repair with heavy equipment and lots of hot work, lost production time, and lost gas.

Citadel Technologies’ team of engineers designed repairs for each defect according to ASME PCC-2 Article 4.1, and recommended a BlackDiamond® repair solution. Only 4 layers of BlackDiamond® were required to repair the defect, even with the high design pressure.

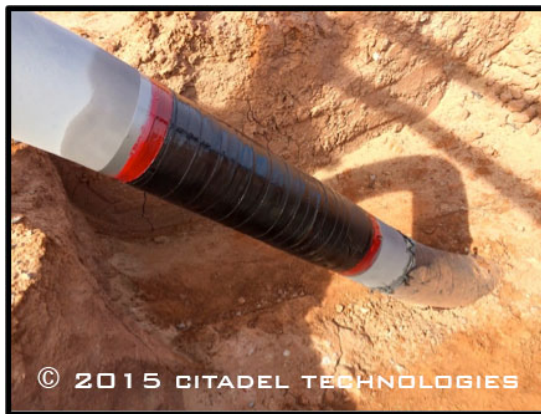
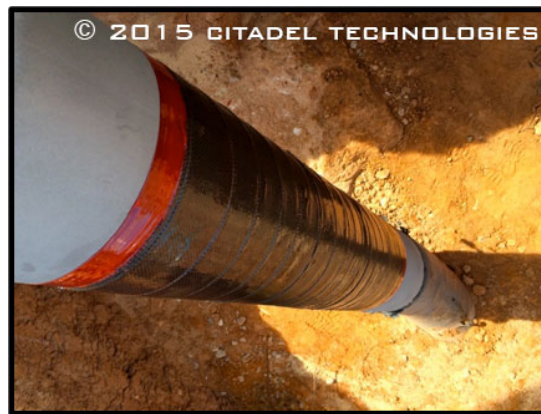
A small team of trained and certified installers installed 4 layers of carbon fiber over the specified repair area, according to the calculations prepared by the Citadel Technologies engineer. The actual installation time was less than an hour, with just two trained technicians. No heavy equipment or hotwork was required for the installation, and the line was in operation with no disruption in production. Below are photos of the completed repair:
