# DiamondWrap® 24” Flare Line Repair in Saudi Arabia

**Customer:** National Oil Company

**Location:** Abu Ali Island, Saudi Arabia

**Pipe Defect:** General internal corrosion, 195 linear meters total repair length

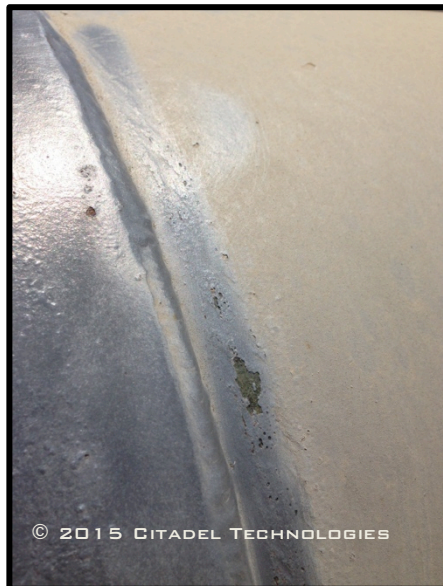
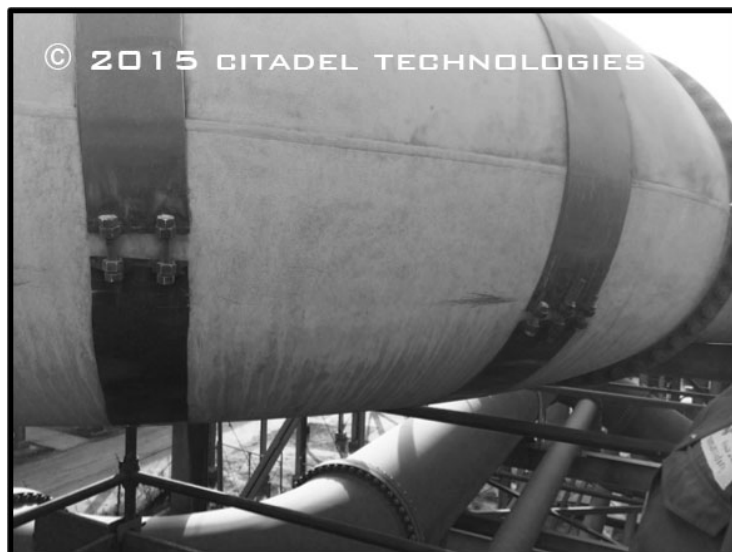
This flare line was suffering from ongoing internal corrosion. Citadel Technologies was approached to design a repair to extend the service life of this line by 2 years.

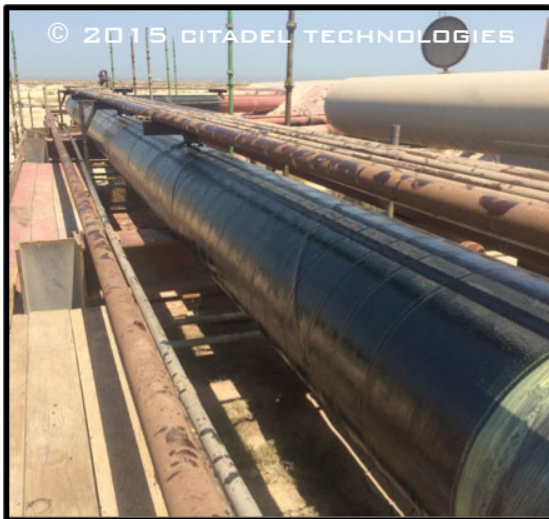
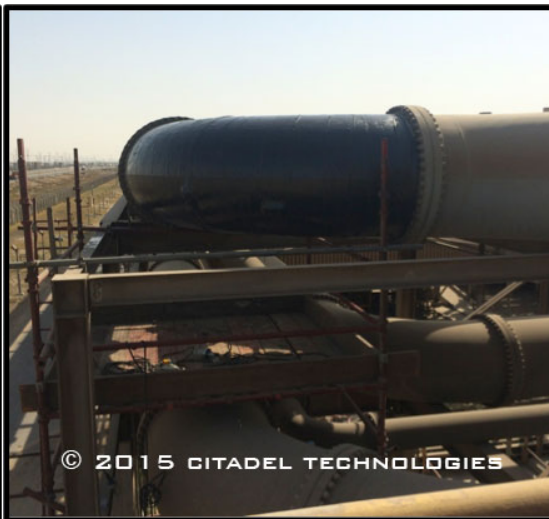
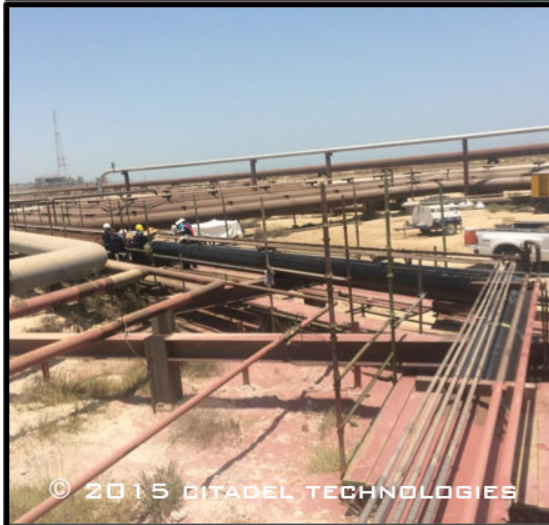
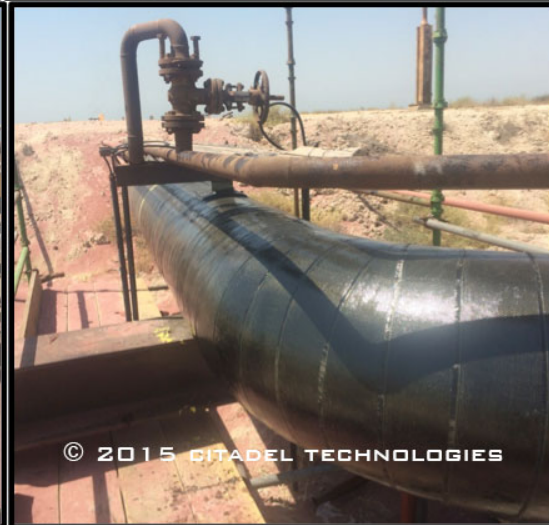
A team of trained and certified installers installed 2 layers of carbon fiber over the specified repair area, according to the calculations prepared by the Citadel Technologies engineer. Some CMF putty was applied over the leak sealing clamps to smooth the rough geometries. The DiamondWrap® repair was then applied over the top. Below are photos of the completed repair:

Citadel Technologies’ team of highly skilled engineers designed a repair according to ASME PCC-2 Article 4.1, and recommended a DiamondWrap® HPT™ repair solution to the national oil company. Only 2 layers of DiamondWrap® HPT™ were required to repair the defect area.
